**Flood Control Project Maintenance
Levee Inspections**

Fall 2019 Levee Maintenance Deficiency Summary Report

Sacramento River Basin

Reclamation District No. 0070 Meridian

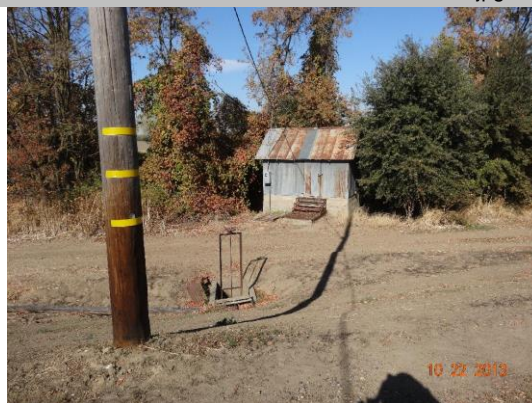
Photo 1 of 3 : UCIP_FA_2019_54252_42036.jpg

DS_ID:21412
FS_ID:54252
EP_NO: 1575
Repair Type: Non-Urgent
Crossing Status: Found
UCIP Comments: 07/24/2019 Permit 9973-1 issued to remove and replace an existing 20-inch steel pipe. (O.Yakimov - DWR UCIP)
Debris scattered on waterward side. Concrete structure on waterward side shows major cracks on the walls. Will need to notify owner. Need to obtain maintenance records to confirm integrity of pipe. This crossing is referenced in the USACE Periodic Inspection as item USACE_CESPK_MRD2_2012_p_0075.
FIELD_STRUCT_DESC: 20-inch steel irrigation discharge pipe through the levee, 17 feet below the crown. Pump and 10-inch slide gate in a pump house on the waterside (WS). Concrete collar at the WS toe. Power pole on the WS slope. Anchor on the landside (LS) slope. Rock revetment on the WS slope. (Plans for installing an irrigation pumping plant and a 20-inch discharge pipe through the levee authorized under Permit No. 1575, 1951 - Meridian Farms Water Company). [Additional Reference(s): DWR Levee Log, 2007].

View of waterward side--appurtenances present pump house, concrete distribution box, screw gate, and power pole.

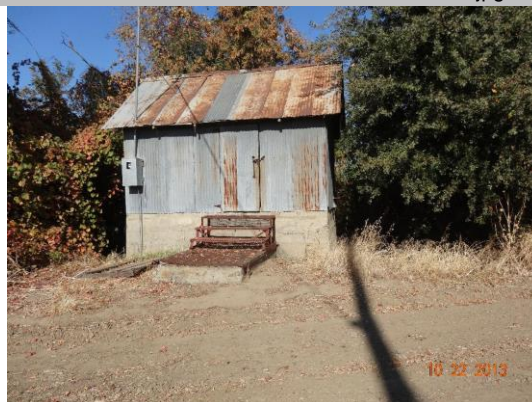
Photo 2 of 3 : UCIP_FA_2019_54252_42041.jpg

Pump station on waterward side.

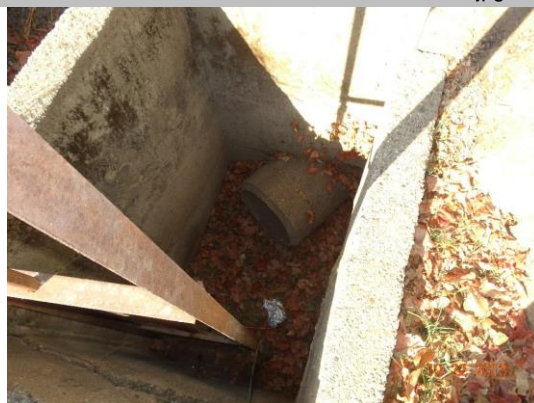
Photo 3 of 3 : UCIP_FA_2019_54252_42042.jpg

Comment Code						
Inspector Comment						
DS_ID:21412						
FS_ID:54252						
EP_NO: 1575						
Repair Type: Non-Urgent						
Crossing Status: Found						
UCIP Comments: 07/24/2019 Permit 9973-1 issued to remove and replace an existing 20-inch steel pipe. (O.Yakimov - DWR UCIP)						
Debris scattered on waterward side. Concrete structure on waterward side shows major cracks on the walls. Will need to notify owner. Need to obtain maintenance records to confirm integrity of pipe. This crossing is referenced in the USACE Periodic Inspection as item						
USACE_CESPK_MRD2_2012_p_0075.						
FIELD_STRUCT_DESC: 20-inch steel irrigation discharge pipe through the levee, 17 feet below the crown. Pump and 10-inch slide gate in a pump house on the waterside (WS). Concrete collar at the WS toe.						
Power pole on the WS slope. Anchor on the landside (LS) slope. Rock revetment on the WS slope. (Plans for installing an irrigation pumping plant and a 20-inch discharge pipe through the levee authorized under Permit No. 1575, 1951 - Meridian Farms Water Company). [Additional

Inside view of concrete distribution box located on waterward side.

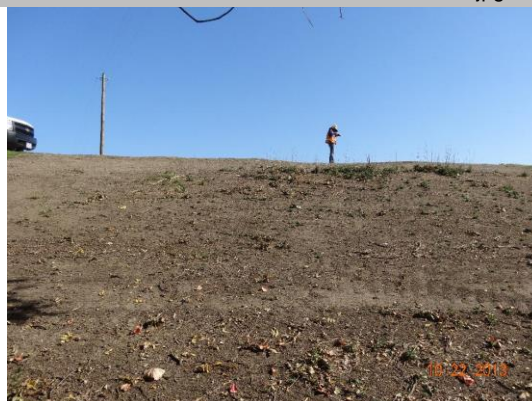
Photo 1 of 3 : UCIP_FA_2019_23885_41814.jpg

Comment Code						
Inspector Comment						
DS_ID:21365 FS_ID:23885 EP_NO: 9973 Repair Type: Non-Urgent Crossing Status: Found UCIP Comments: Cut to levee toe found on landward side. Unable to determine if crossing is being used. If crossing is no longer used by owner, the owner will need to coordinate with DWR Inspector and CVFPB to remove crossing according to Title 23 requirements. This crossing is referenced in the USACE Periodic Inspection as item USACE_CESPK_MRD2_2012_p_0099. FIELD_STRUCT_DESC: 18-inch steel irrigation discharge pipe through the levee, 18.8 feet below the crown. Slant pump on the waterside (WS). Slide gate on a gate structure on the WS. (Retention of an 18-inch steel pipe through the levee, 18.8 feet below the crown, and a slide gate authorized under Automatic Board Order (ABO) issued as Permit No. 9973, 1974 - Pearl V. Clark). [Additional Reference(s): DWR Levee Log, 2007. USACE Sacramento O&M Manual 134, June 1953, (Station 399+34)]. FS Date: 10/22/2013

View of waterward slope.

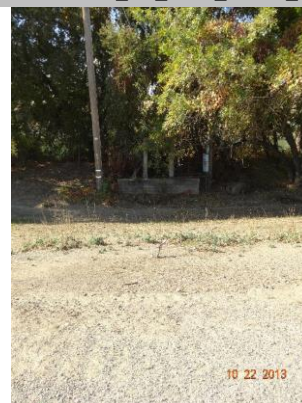
Photo 2 of 3 : UCIP_FA_2019_23885_41817.jpg

Overview of waterward slope.

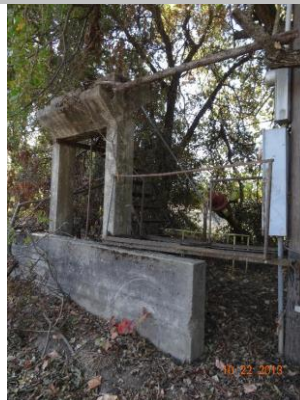
Photo 3 of 3 : UCIP_FA_2019_23885_41815.jpg

Comment Code						
Inspector Comment						
DS_ID:21365 FS_ID:23885 EP_NO: 9973 Repair Type: Non-Urgent Crossing Status: Found UCIP Comments: Cut to levee toe found on landward side. Unable to determine if crossing is being used. If crossing is no longer used by owner, the owner will need to coordinate with DWR Inspector and CVFPB to remove crossing according to Title 23 requirements. This crossing is referenced in the USACE Periodic Inspection as item USACE_CESPK_MRD2_2012_p_0099. FIELD_STRUCT_DESC: 18-inch steel irrigation discharge pipe through the levee, 18.8 feet below the crown. Slant pump on the waterside (WS). Slide gate on a gate structure on the WS. (Retention of an 18-inch steel pipe through the levee, 18.8 feet below the crown, and a slide gate authorized under Automatic Board Order (ABO) issued as Permit No. 9973, 1974 - Pearl V. Clark). [Additional Reference(s): DWR Levee Log, 2007. USACE Sacramento O&M Manual 134, June 1953, (Station 399+34)]. FS Date: 10/22/2013

Concrete structure located on waterward side with screw gate.

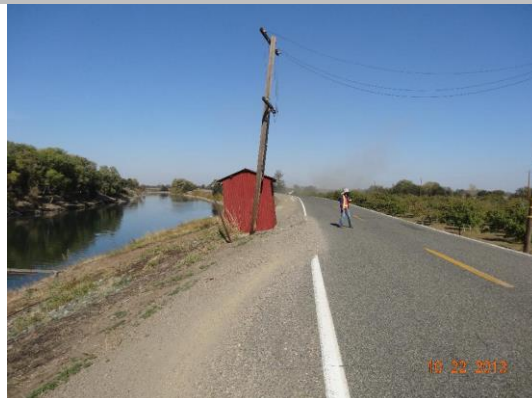
Photo 1 of 3 : UCIP_FA_2019_23888_41819.jpg

Comment Code						
Inspector Comment						
DS_ID:21366 FS_ID:23888 EP_NO: 9996 Repair Type: Non-Urgent Crossing Status: Found UCIP Comments: Need inside photo of the concrete distribution box located at the landward toe. Debris found on waterward slope (conduit running parallel to levee). This crossing is referenced in the USACE Periodic Inspection as item USACE_CESPK_MRD2_2012_p_0124. FIELD_STRUCT_DESC: 12-inch steel irrigation discharge pipe through the levee, 24 feet below the crown. Gate valve in a concrete U-shaped headwall on the waterside (WS) slope. Pump and switch house on the WS shoulder. Discharge box at the landside (LS) toe. (Retention of a 12-inch steel pipe through the levee, 24 feet below the crown, a pump, a gate valve, a switch house, and a discharge box authorized under Automatic Board Order (ABO) issued as Permit No. 9996, 1974 - Chas. F. and Nora M. Reische, et al.). [Additional Reference(s): DWR Levee Log, 2007]. FS Date: 10/22/2013

View of levee crown and waterward side.

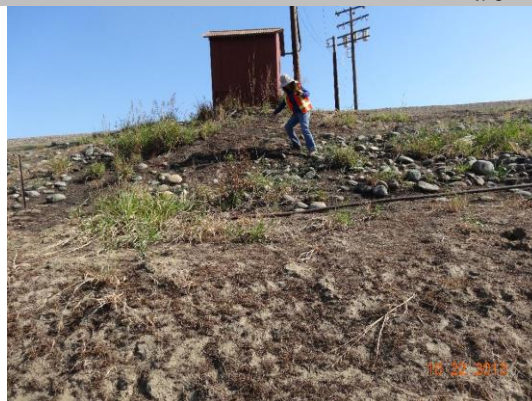
Photo 2 of 3 : UCIP_FA_2019_23888_41822.jpg

View of slope on waterward side.

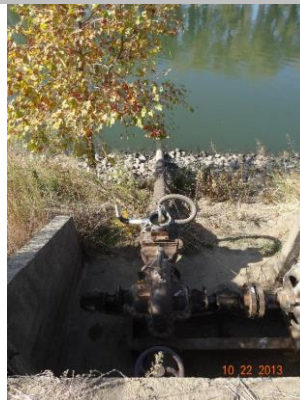
Photo 3 of 3 : UCIP_FA_2019_23888_41821.jpg

Comment Code						
Inspector Comment						
DS_ID:21366 FS_ID:23888 EP_NO: 9996 Repair Type: Non-Urgent Crossing Status: Found UCIP Comments: Need inside photo of the concrete distribution box located at the landward toe. Debris found on waterward slope (conduit running parallel to levee). This crossing is referenced in the USACE Periodic Inspection as item USACE_CESPK_MRD2_2012_p_0124. FIELD_STRUCT_DESC: 12-inch steel irrigation discharge pipe through the levee, 24 feet below the crown. Gate valve in a concrete U-shaped headwall on the waterside (WS) slope. Pump and switch house on the WS shoulder. Discharge box at the landside (LS) toe. (Retention of a 12-inch steel pipe through the levee, 24 feet below the crown, a pump, a gate valve, a switch house, and a discharge box authorized under Automatic Board Order (ABO) issued as Permit No. 9996, 1974 - Chas. F. and Nora M. Reische, et al.). [Additional Reference(s): DWR Levee Log, 2007]. FS Date: 10/22/2013

View of U-concrete headwall with positive closure device, photo 1 of 2.

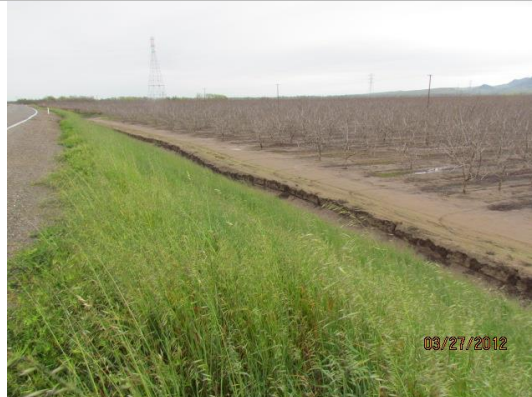
Photo 1 of 1 : FA_2019_RD0070_30_1_20190822_00001.jpg

LM Start	2.16	Rating **	M	Issue No.	1
LM End	2.32	Issue Type +	En	Location *	LS
Category	Earthen Levee			GPS Latitude/Longitude	
				Start	End
Item	Encroachments			39.168854 °	39.166503 °
				-121.936223 °	-121.935547 °
DWR ID	DWR_RD0070_02_s _ 2012_1				
Comment Code					
DT : Ditch					
Inspector Comment

Agricultural ditch along the landside toe.

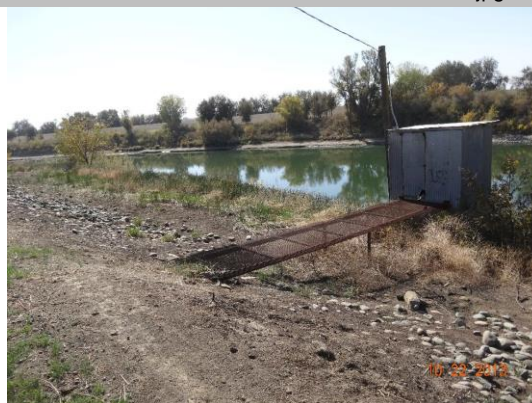
Photo 1 of 3 : UCIP_FA_2019_23891_41835.jpg

Comment Code						
Inspector Comment						
DS_ID:21368 FS_ID:23891 EP_NO: 9969 Repair Type: Non-Urgent Crossing Status: Found UCIP Comments: Landward slope too steep--need photo of the inside of concrete distribution box. Dense vegetation limits the inspector's visibility to identify signs of pipe failure (leaks) along the waterward slope. Recommend removing vegetation along pipe alignment to conduct proper inspection of structure and appurtenances. This crossing is referenced in the USACE Periodic Inspection as item USACE_CESPK_MRD2_2012_p_0158. FIELD_STRUCT_DESC: 20-inch (not 24-inch as mentioned in the permit) steel irrigation discharge pipe through the levee, 27 feet below the crown. Corrugated metal cutoff wall around the pipe at the center of the levee. Pump and gate valve in a pump house on the waterside (WS) slope. Pipe discharges into a concrete box at the landside (LS) toe. (Retention of a 24-inch steel pipe through the levee, 27 feet below the crown, a pump and gate valve, a concrete box, and a service pole authorized under Automatic Board Order (ABO) No. 9969, 1974 - Edwin J. and Vivian L. Burrows). [Additional Reference(s): DWR Levee Log, 2007. USACE Sacramento O&M Manual 134, June 1953, (Station 455+39), 24-inch listed]. FS Date: 10/22/2013

View of waterward side.

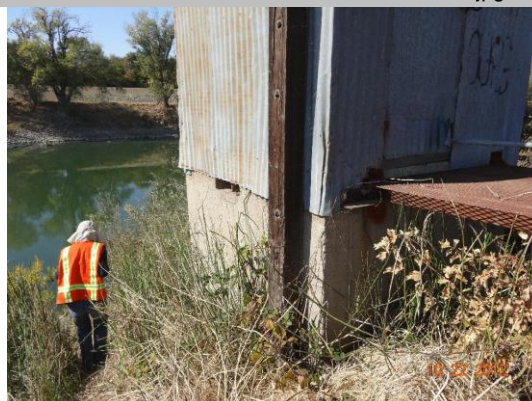
Photo 2 of 3 : UCIP_FA_2019_23891_41833.jpg

Comment Code						
Inspector Comment						
DS_ID:21368 FS_ID:23891 EP_NO: 9969 Repair Type: Non-Urgent Crossing Status: Found UCIP Comments: Landward slope too steep--need photo of the inside of concrete distribution box. Dense vegetation limits the inspector's visibility to identify signs of pipe failure (leaks) along the waterward slope. Recommend removing vegetation along pipe alignment to conduct proper inspection of structure and appurtenances. This crossing is referenced in the USACE Periodic Inspection as item USACE_CESPK_MRD2_2012_p_0158. FIELD_STRUCT_DESC: 20-inch (not 24-inch as mentioned in the permit) steel irrigation discharge pipe through the levee, 27 feet below the crown. Corrugated metal cutoff wall around the pipe at the center of the levee. Pump and gate valve in a pump house on the waterside (WS) slope. Pipe discharges into a concrete box at the landside (LS) toe. (Retention of a 24-inch steel pipe through the levee, 27 feet below the crown, a pump and gate valve, a concrete box, and a service pole authorized under Automatic Board Order (ABO) No. 9969, 1974 - Edwin J. and Vivian L. Burrows). [Additional Reference(s): DWR Levee Log, 2007. USACE Sacramento O&M Manual 134, June 1953, (Station 455+39), 24-inch listed]. FS Date: 10/22/2013

Pump station located on waterward side.

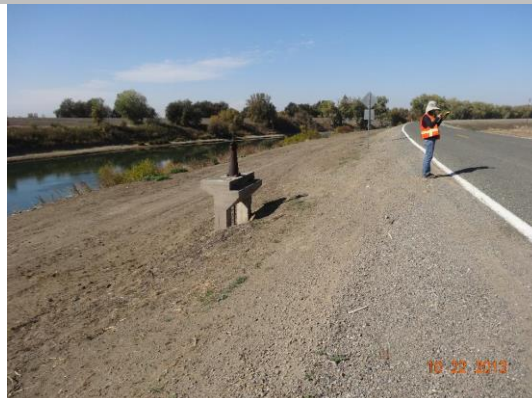
Photo 1 of 3 : UCIP_FA_2019_23892_41839.jpg

Comment Code					
Inspector Comment					
DS_ID:21369 FS_ID:23892 EP_NO: N/A Repair Type: Non-Urgent Crossing Status: Found UCIP Comments: If crossing is no longer used by owner, the owner will need to coordinate with DWR Inspector and CVFPB to remove crossing according to Title 23 requirements. Dense vegetation limits the inspector's visibility to identify signs of pipe failure (leaks) along the slope. Recommend removing vegetation along pipe alignment to conduct proper inspection of structure and appurtenances. This crossing is referenced in the USACE Periodic Inspection as item USACE_CESPK_MRD1_2012_p_0167. FIELD_STRUCT_DESC: *ABANDONED* 24-inch corrugated metal drainage pipe through the levee, 21 feet below the crown. Slide gate on the waterside (WS) end. (Cat. IVA). [Additional Reference(s): DWR Levee Log, 2007]. FS Date: 10/22/2013

View of waterward side.

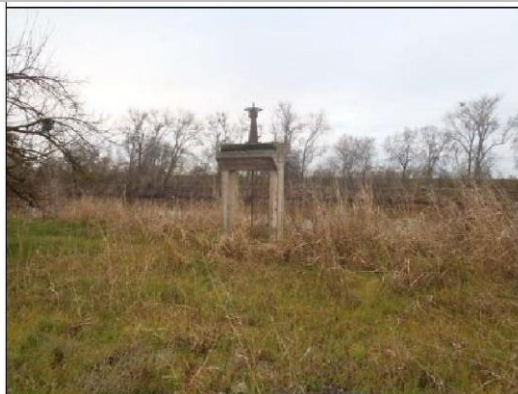
Photo 1 of 2 : UCIP_FA_2019_24115_42495.jpg

Comment Code					
Inspector Comment					
DS_ID:21370 FS_ID:24115 EP_NO: N/A Repair Type: Non-Urgent Crossing Status: Found UCIP Comments: No connection present--need to contact owner to determine if owner plans to use. If crossing is no longer in use owner will need to coordinate with DWR inspector and CVFPB to remove according to Title 23 requirements. This crossing is referenced in the USACE Periodic Inspection as USACE_CESPK_MRD2_2012_p_0197. FIELD_STRUCT_DESC: *ABANDONED* 24-inch drainage pipe of an unknown material through the levee, 18.5 feet below the crown. Slide gate on a concrete gate structure on the berm. [Additional Reference(s): DWR Levee Log, 2007]. FS Date: 10/22/2013

View of waterward side--photo is from USACE PI Report draft final issue USACE_CESPK_MRD2_2012_p_0197.

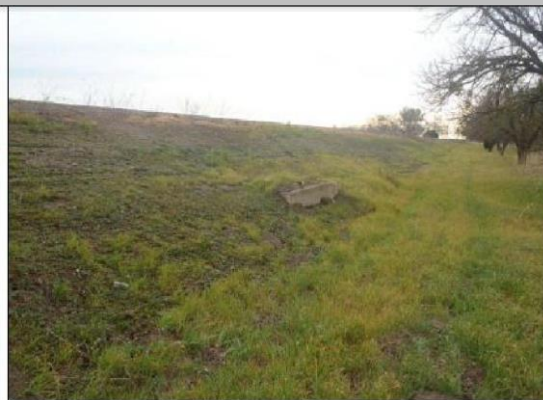
Photo 2 of 2 : UCIP_FA_2019_24115_42496.jpg

View of landward side--photo is from USACE PI Report draft final issue USACE_CESPK_MRD2_2012_p_0197.

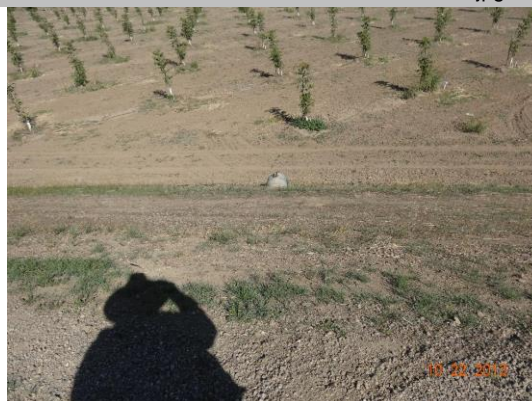
Photo 1 of 2 : UCIP_FA_2019_24117_42502.jpg

Comment Code						
Inspector Comment						
DS_ID:21371						
FS_ID:24117						
EP_NO: N/A						
Repair Type: Non-Urgent						
Crossing Status: Found						
UCIP Comments: No connection present--need to contact owner to determine if owner plans to use. If crossing is no longer in use owner will need to coordinate with DWR inspector and CVFPB to remove according to Title 23 requirements. This crossing is referenced in the USACE Periodic Inspection as USACE_CESPK_MRD2_2012_p_0197.						
FIELD_STRUCT_DESC: *ABANDONED* 24-inch drainage pipe of an unknown material through the levee, 18.5 feet below the crown. Slide gate on a concrete gate structure on the berm. [Additional Reference(s): DWR Levee Log, 2007].						
FS Date: 10/22/2013

View of pipe on landward side.

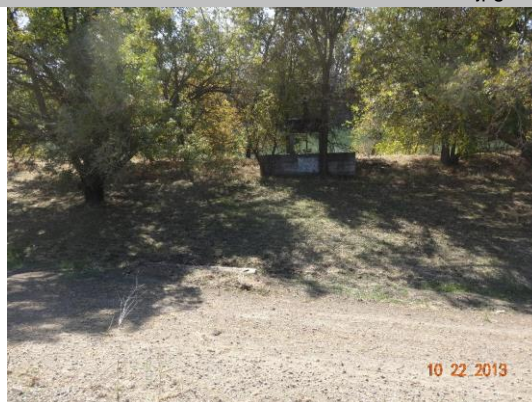
Photo 2 of 2 : UCIP_FA_2019_24117_42501.jpg

View of concrete headwall and screw gate on waterward side.

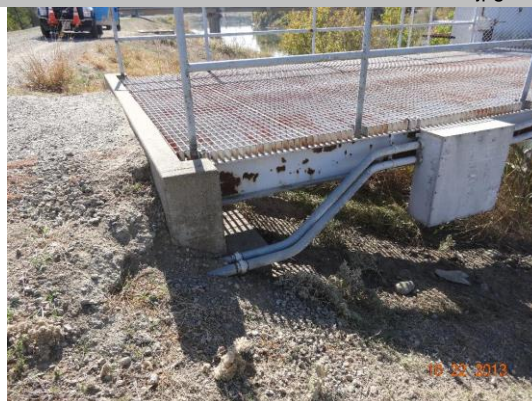
Photo 1 of 1 : UCIP_FA_2019_47028_42570.jpg

Comment Code						
Inspector Comment						
DS_ID:21428 FS_ID:47028 EP_NO: N/A Repair Type: Non-Urgent Crossing Status: Found UCIP Comments: Pump station will be removed. This crossing will need to be updated once the pump station is removed. This crossing is referenced in the USACE Periodic Inspection as item USACE_CESPK_MRD2_2012_p_0235. FIELD_STRUCT_DESC: [Meridian Farms Water Company Pumping Plant No. 2] 1 of 4: 2.5-inch steel (not iron, as mentioned in the desk study) electrical conduit through the levee, 1.9 feet below the crown. Two concrete cutoff walls, one at each shoulder. Concrete pump pit on the waterside (WS) slope. Three pumps on a structure on the WS. Walkway to the pumps. Concrete headwall on the landside (LS). Debris deflectors in the river. (Plans for construction of a pumping plant and related facilities to replace an existing plant on the left bank of the Sacramento River authorized under Permit No. 4525, 1964 - Meridian Farms Water Company. Plans for existing pumping plant to be demolished with all pipes removed and replaced with a new Meridian Diversion pumping facility, two retractable fish screens, and a 72-inch gravity feed intake pipe under the levee authorized under Permit No. 18762, 2013 - Meridian Farms Water Company). [Additional Reference(s): DWR Levee Log, 2007]. FS Date: 10/22/2013

Conduits through levee along walkway.

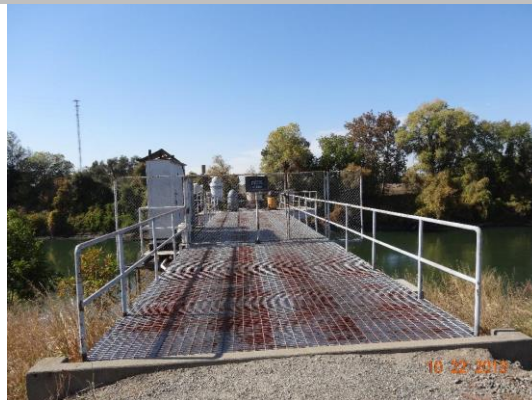
Photo 1 of 3 : UCIP_FA_2019_47030_42563.jpg

View of walkway and pump station on waterward side.

DS_ID:21429
FS_ID:47030
EP_NO: N/A
Repair Type: Non-Urgent
Crossing Status: Found
UCIP Comments: Pump is to be demolished will all pipes removed. Will need to update record. This crossing is referenced in the USACE Periodic Inspection as item USACE_CESPK_MRD2_2012_p_0235.
FIELD_STRUCT_DESC: [Meridian Farms Water Company Pumping Plant No. 1] 3 of 4: 42-inch steel irrigation discharge pipe and 2-inch polyvinyl chloride (PVC) electrical conduit through the levee, 24 and 3 feet below the crown, respectively. 42-inch pipe is concrete encased through the levee. Two concrete cutoff walls, one at each shoulder. Slide gate in a surge box on the waterside (WS). Concrete pump pit on the WS slope. Three pumps on a structure on the WS. Walkway to the pumps with an electrical control box. Concrete headwall on the landside (LS). Pipe discharges into a concrete lined irrigation ditch on the LS. Debris deflectors in the river. Power poles on the LS. (Plans to enlarge the Meridian Farms Water Company Pump Station Facility No. 1 by adding a 150-horsepower pump, a 42-inch water pipe, and a 2-inch electrical conduit through the levee authorized under Permit No. 13380, 1982 - Meridian Farms Water Company. Plans for existing pumping plant to be demolished with all pipes removed and replaced with a new Meridian Diversion pumping facility, two retractable fish screens, and a 72-inch gravity feed intake pipe under the levee authorized under Permit No. 18762, 2013 - Meridian Farms Water Company). [Additional Reference(s): DWR Levee Log, 2007].

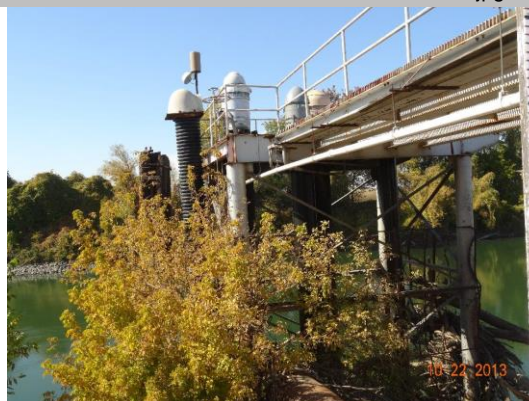
Photo 3 of 3 : UCIP_FA_2019_47030_42569.jpg

Item	DRAFT DWR UCIP Field Study		39.147259 °	39.147259 °								
			-121.916725 °	-121.916725 °								
DWR ID	21429											
Comment Code												
Inspector Comment												
DS_ID:21429 FS_ID:47030 EP_NO: N/A Repair Type: Non-Urgent Crossing Status: Found UCIP Comments: Pump is to be demolished will all pipes removed. Will need to update record. This crossing is referenced in the USACE Periodic Inspection as item USACE_CESPK_MRD2_2012_p_0235. FIELD_STRUCT_DESC: [Meridian Farms Water Company Pumping Plant No. 1] 3 of 4: 42-inch steel irrigation discharge pipe and 2-inch polyvinyl chloride (PVC) electrical conduit through the levee, 24 and 3 feet below the crown, respectively. 42-inch pipe is concrete encased through the levee. Two concrete cutoff walls, one at each shoulder. Slide gate in a surge box on the waterside (WS). Concrete pump pit on the WS slope. Three pumps on a structure on the WS. Walkway to the pumps with an electrical control box. Concrete headwall on the landside (LS). Pipe discharges into a concrete lined irrigation ditch on the LS. Debris deflectors in the river. Power poles on the LS. (Plans to enlarge the Meridian Farms Water Company Pump Station Facility No. 1 by adding a 150-horsepower pump, a 42-inch water pipe, and a 2-inch electrical conduit through the levee authorized under Permit No. 13380, 1982 - Meridian Farms Water Company. Plans for existing pumping plant to be demolished with all pipes removed and replaced with a new Meridian Diversion pumping facility, two retractable fish screens, and a 72-inch gravity feed intake pipe under the levee authorized under Permit No. 18762, 2013 - Meridian Farms Water Company). [Additional Reference(s): DWR Levee Log, 2007]. FS Date: 10/22/2013

View of pumps located on waterward side.

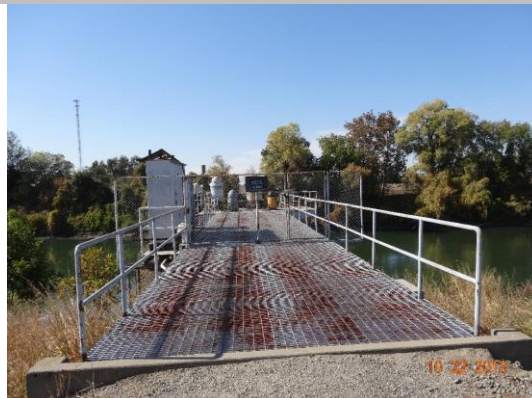
Photo 1 of 3 : UCIP_FA_2019_47032_42076.jpg

DS_ID:21373
FS_ID:47032
EP_NO: N/A
Repair Type: Non-Urgent
Crossing Status: Indicator Found
UCIP Comments: Unable to confirm 54-inch pipe only found 42-inch pipe. Pump station is to be removed. Need to update record once crossing has been modified. This crossing is referenced in the USACE Periodic Inspection as item USACE_CESPK_MRD2_2012_p_0235.
FIELD_STRUCT_DESC: [Meridian Farms Water Company Pumping Plant No. 2] 4 of 4: 54-inch steel irrigation discharge pipe through the levee, 24 feet below the crown. Pipe is concrete encased through the levee. Two concrete cutoff walls, one at each shoulder. Slide gate in a surge box on the waterside (WS). Concrete pump pit on the WS slope. Three pumps on a structure on the WS. Walkway to the pumps. Concrete headwall on the landside (LS). Pipe discharges into a concrete lined irrigation ditch on the LS. Debris deflectors in the river. (Plans for construction of a pumping plant and related facilities to replace an existing plant on the left bank of the Sacramento River authorized under Permit No. 4525, 1964 - Meridian Farms Water Company. Plans for existing pumping plant to be demolished with all pipes removed and replaced with a new Meridian Diversion pumping facility, two retractable fish screens, and a 72-inch gravity feed intake pipe under the levee authorized under Permit No. 18762, 2013 - Meridian Farms Water Company). [Additional Reference(s): DWR Levee Log, 2007].

View of walkway and pump station on waterward side.

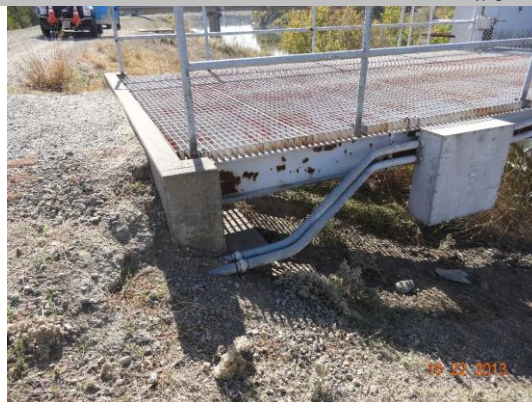
Photo 2 of 3 : UCIP_FA_2019_47032_42080.jpg

View of conduit pipes through levee.

Comment Code						
Inspector Comment						
DS_ID:21373 FS_ID:47032 EP_NO: N/A Repair Type: Non-Urgent Crossing Status: Indicator Found UCIP Comments: Unable to confirm 54-inch pipe only found 42-inch pipe. Pump station is to be removed. Need to update record once crossing has been modified. This crossing is referenced in the USACE Periodic Inspection as item USACE_CESPK_MRD2_2012_p_0235. FIELD_STRUCT_DESC: [Meridian Farms Water Company Pumping Plant No. 2] 4 of 4: 54-inch steel irrigation discharge pipe through the levee, 24 feet below the crown. Pipe is concrete encased through the levee. Two concrete cutoff walls, one at each shoulder. Slide gate in a surge box on the waterside (WS). Concrete pump pit on the WS slope. Three pumps on a structure on the WS. Walkway to the pumps. Concrete headwall on the landside (LS). Pipe discharges into a concrete lined irrigation ditch on the LS. Debris deflectors in the river. (Plans for construction of a pumping plant and related facilities to replace an existing plant on the left bank of the Sacramento River authorized under Permit No. 4525, 1964 - Meridian Farms Water Company. Plans for existing pumping plant to be demolished with all pipes removed and replaced with a new Meridian Diversion pumping facility, two retractable fish screens, and a 72-inch gravity feed intake pipe under the levee authorized under Permit No. 18762, 2013 - Meridian Farms Water Company). [Additional Reference(s): DWR Levee Log, 2007]. FS Date: 10/22/2013

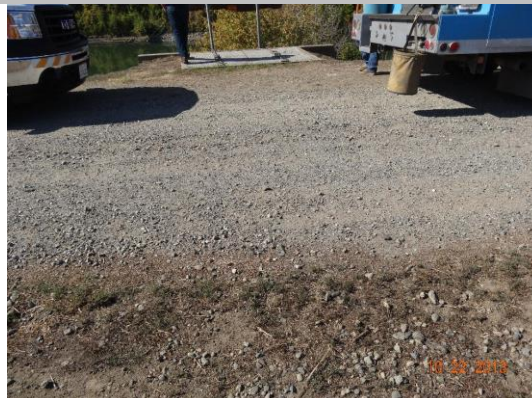
Photo 1 of 3 : UCIP_FA_2019_24165_42573.jpg

Comment Code					
Inspector Comment					
DS_ID:21374 FS_ID:24165 EP_NO: 767 Repair Type: Non-Urgent Crossing Status: Found UCIP Comments: Need to contact owner to determine if crossing is still active and to determine last inspection date. Will need copy of letter showing crossings passed inspection. This crossing is referenced in the USACE Periodic Inspection as item USACE_CESPK_MRD2_2012_p_0237. FIELD_STRUCT_DESC: 3-inch steel natural gas pipeline (not 3.5-inch, as mentioned in the desk study) through the levee, 3 feet below the crown. 8-foot by 10-foot by 1-foot concrete inspection well with a metal cover on the waterside (WS) shoulder. Rock revetment on the WS slope. Painted aluminum marker on the WS. Contact information provided on marker: (916) 742-7344 and for emergencies call (916) 742-3251. (Plans for the construction of a natural gas pipeline across the Sacramento River and the east and west levees thereof authorized under Permit No. 767, 1938 - Pacific Gas and Electric Company [PG&E]). [Additional Reference(s): DWR Levee Log, 2007]. FS Date: 10/22/2013

View of levee crown.

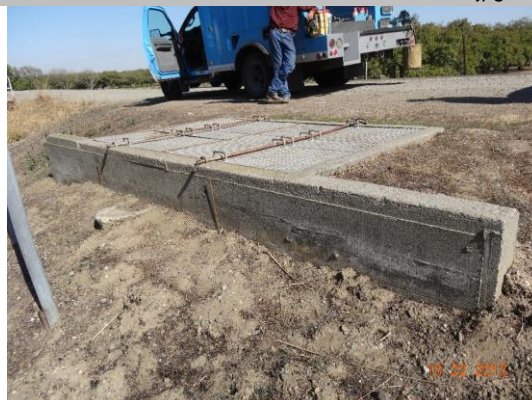
Photo 2 of 3 : UCIP_FA_2019_24165_42575.jpg

Concrete headwall on waterward side.

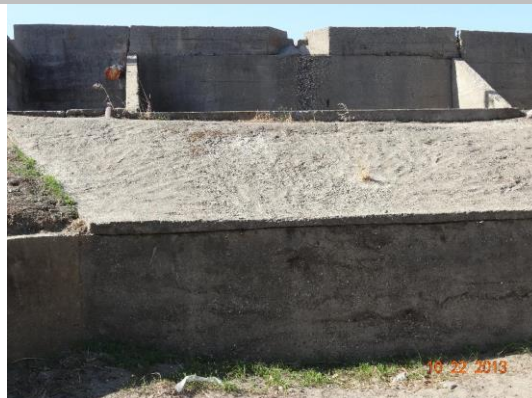
Photo 1 of 1 : UCIP_FA_2019_23959_42096.jpg

Comment Code					
Inspector Comment					
DS_ID:21375 FS_ID:23959 EP_NO: 1123 Repair Type: Non-Urgent Crossing Status: Indicator Found UCIP Comments: No connection present. If crossing is no longer in use owner will need to coordinate with DWR inspector and CVFPB to remove according to Title 23 requirements. This crossing is referenced in the USACE Periodic Inspection as item USACE_CESPK_MRD2_2012_p_0240. FIELD_STRUCT_DESC: 1 of 3: 10-inch water supply pipe of an unknown material through the levee, 2 feet below the crown. Seed washing plant with concrete catch basin and pan on the landside (LS) slope. Concrete sump on the waterside (WS) slope. Intake pump on the WS slope. (Plans for installing a seed washer on the LS slope and influent and effluent pipes through the levee authorized under Permit No. 1123, 1946 - G. J. Reitter). [Additional Reference(s): DWR Levee Log, 2007. USACE Sacramento O&M Manual 134, June 1953, (Station 496+25)]. FS Date: 10/22/2013

Concrete headwall located on landward side--no pipe. Only visible pipe is the pipe located at the far left (downstream end).

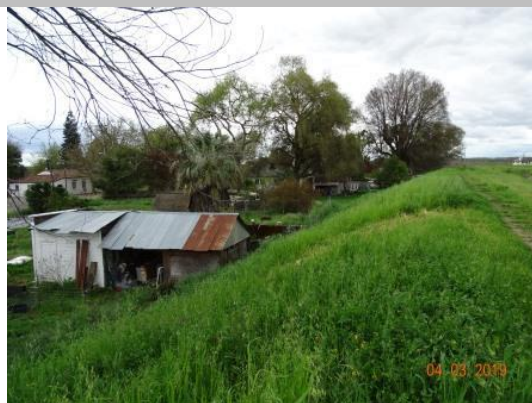
Photo 1 of 1 : FA_2019_RD0070_30_92_20190822_00025.jpg

LM Start	4.35	Rating **	U	Issue No.	92
LM End	4.35	Issue Type +	En	Location *	LS
Category	Earthen Levee		GPS Latitude/Longitude		
			Start	End	
Item	Encroachments		39.143750°	39.143750°	
			-121.917460°	-121.917460°	
DWR ID	DWR_RD0070_02_s_2019_92				
Comment Code					
BU : Building					
Inspector Comment

View of the unpermitted outbuilding at the landside toe. Spring 2019.

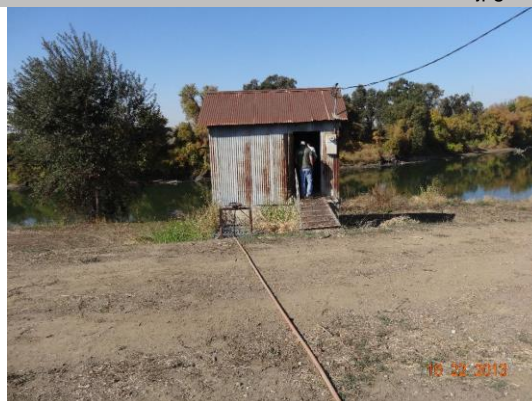
Photo 1 of 3 : UCIP_FA_2019_23962_42099.jpg

UCIP Comments: Unable to confirm if crossing corresponds to permit 9998. Pipe size is different then the pipe size listed in the desk study. Unable to confirm if structure on landward side is a pump house. Need to coordinate with owner to obtain permit record for crossing. Need to verify status of crossing. Permit authorized 24 inch pipe. Pipe through levee is 30 inches. Unable to find stand pipe in field. Dense vegetation limits the inspector's visibility to identify signs of pipe failure (leaks) along the slope. Recommend removing vegetation along pipe alignment to conduct proper inspection of structure and appurtenances. This crossing is referenced in the USACE Periodic Inspection as item USACE_CESPK_MRD2_2012_p_0264.

FIELD_STRUCT_DESC: 30-inch (not 24-inch as indicated in desk study) corrugated metal irrigation discharge pipe through the levee, 15.5 feet below the crown. Slide gate in a concrete distribution box at the landside (LS) toe. Pump in a pump house on the LS. Service pole and ramp on the waterside (WS) slope. Concrete box with air vents on the WS end. (Retention of a 24-inch corrugated metal pipe (CMP) through the levee, 15.5 feet below the crown, a pump, a slide gate, a service pole, and a concrete distribution box authorized under Automatic Board Order (ABO) issued as Permit No. 9998, 1974 - Robert Tod Ruse, Trustee. Plans to install an 18-inch polyvinyl chloride (PVC) pipe through an existing 24-inch steel pipe under the levee with annular space grouted authorized under Permit No. 16228, 1994 - Mike and Carol Churkin). [Additional Reference(s): DWR Levee Log, 2007. USACE Sacramento O&M Manual 134, June 1953, (Station 516+06)]. FS Date: 10/22/2013

View of pump house located on waterward side.

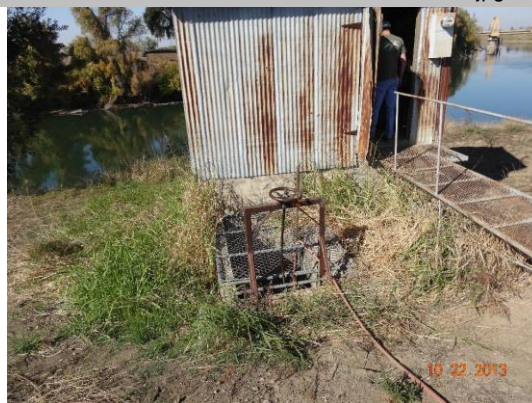
Photo 2 of 3 : UCIP_FA_2019_23962_42104.jpg

Positive closure device located at the waterward side inside concrete distribution box.

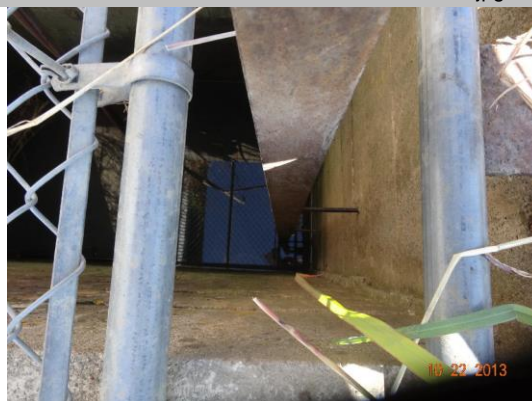
Photo 3 of 3 : UCIP_FA_2019_23962_42101.jpg

Photo of the concrete distribution box located on waterward side.

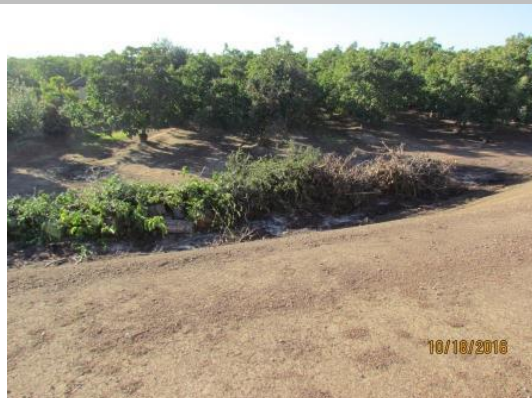
Photo 1 of 1 : FA_2019_RD0070_30_53_20190822_00004.jpg

LM Start	4.59	Rating **	M	Issue No.	53
LM End	4.59	Issue Type +	En	Location *	LS
Category	Earthen Levee			GPS Latitude/Longitude	
				Start	End
Item	Encroachments			39.140975 °	39.140975 °
				-121.919907 °	-121.919907 °
DWR ID	DWR_RD0070_02_f_2016_53				
Comment Code					
PR : Prunings					
Inspector Comment					
Remove prunings from the landside toe.

View of the prunings along the landside toe.

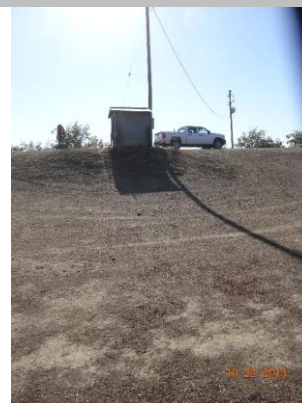
Photo 1 of 3 : UCIP_FA_2019_24166_42581.jpg

Comment Code					
Inspector Comment					
DS_ID:21380 FS_ID:24166 EP_NO: 9970 Repair Type: Non-Urgent Crossing Status: Found UCIP Comments: Need to coordinate with owner to determine status of crossing. No pump is located inside the pump house located on waterward side. If crossing is no longer in use owner will need to contact the CVFPB to comply with Title 23. Dense vegetation limits the inspector's visibility to identify signs of pipe failure (leaks) along the slope. Recommend removing vegetation along pipe alignment to conduct proper inspection of structure and appurtenances. This crossing is referenced in the USACE Periodic Inspection as item USACE_CESPK_MRD2_2012_p_0274. FIELD_STRUCT_DESC: 10-inch steel irrigation discharge pipe through the levee, 4.8 feet below the crown. Corrugated metal cutoff wall around the pipe at the center of the levee. Siphon breaker on the landside (LS) slope, not found. Pump in a pump house on the waterside (WS) shoulder. Shutoff valve on the LS. Concrete discharge box at the LS toe. (Retention of a 10-inch steel pipe through the levee, 4.8 feet below the crown, a pump, a service pole, a siphon breaker, and a concrete discharge box authorized under Automatic Board Order (ABO) issued as Permit No. 9970, 1974 - Arnold Chesini). [Additional Reference(s): DWR Levee Log, 2007. USACE Sacramento O&M Manual 134, June 1953, (Station 526+71)]. FS Date: 10/22/2013

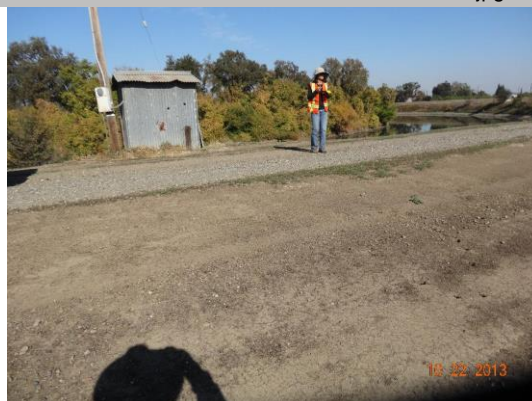
Photo 2 of 3 : UCIP_FA_2019_24166_42580.jpg

View of levee crown and pump house photo taken from landward side.

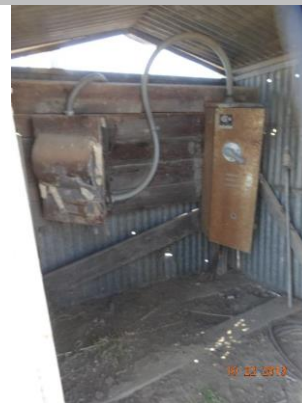
Photo 3 of 3 : UCIP_FA_2019_24166_42583.jpg

View of the inside of pump house--no pump.

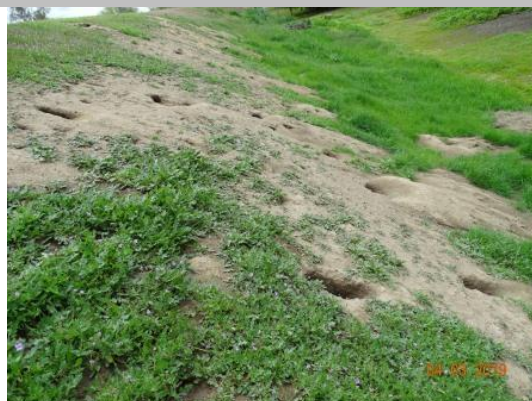
Photo 2 of 3 : FA_2019_RD0070_30_89_20190822_00023.jpg

LM Start	5.03	Rating **	U	Issue No.	89 (cont)	
LM End	5.08	Issue Type +	Ma	Location *	LS	
Category	Earthen Levee			GPS Latitude/Longitude		
				Start		End
Item	Animal Control			39.141997 °		39.141905 °
				-121.927776 °		-121.928654 °
DWR ID	DWR_RD0070_02_s_2019_89					
Comment Code						
A3 : No rodents visible, but rodent burrows visible; need to backfill and compact or grout burrows.						
Inspector Comment

Another view of the rodent burrows on the landside slope. Spring 2019.

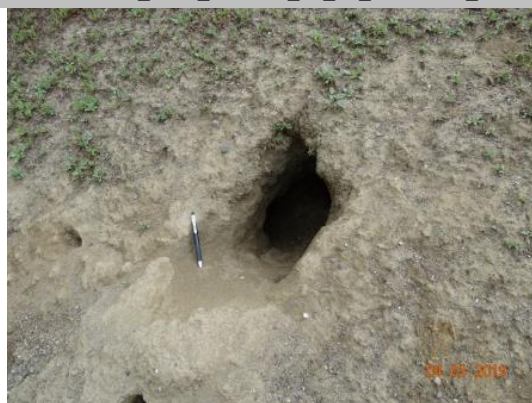
Photo 3 of 3 : FA_2019_RD0070_30_89_20190822_00024.jpg

Upclose view of a large rodent burrow. Spring 2019.

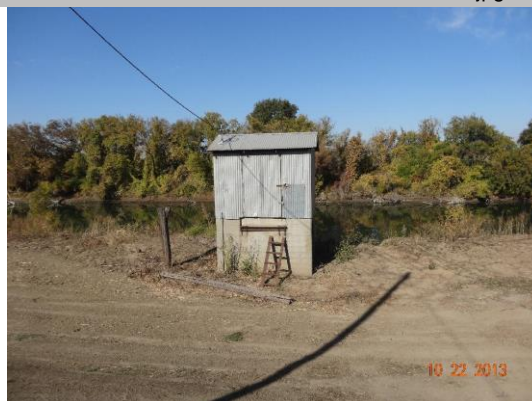
Photo 1 of 3 : UCIP_FA_2019_23964_42114.jpg

Comment Code						
Inspector Comment						
DS_ID:21383 FS_ID:23964 EP_NO: 9984 Repair Type: Non-Urgent Crossing Status: Found UCIP Comments: Will need to contact owner. Need to obtain maintenance records and clarify modifications made at to crossing (size). Additional crossing visible through concrete headwall on landward side--crossing has been capped (see photo). NEED TO CONFIRM PIPE SIZE!!! This crossing is referenced in the USACE Periodic Inspection as item USACE_CESPK_MRD2_2012_p_0289. FIELD_STRUCT_DESC: 12-inch steel irrigation discharge pipe (not 24-inch, as referenced in the permit) through the levee, 13.8 feet below the crown. Gate valve on the waterside (WS). Pump in a pump house on the WS. Concrete distribution box at the landside (LS) toe. (Retention of a 24-inch steel pipe through the levee, 13.8 feet below the crown, a pump, a gate valve, and a concrete distribution box authorized under Automatic Board Order (ABO) issued as Permit No. 9984, 1974 - Edward E. and Alice B. Lemos, et al.). [Additional Reference(s): DWR Levee Log, 2007. USACE Sacramento O&M Manual 134, June 1953, (Station 555+09), 24-inch listed]. FS Date: 10/22/2013

Pump house located on waterward side.

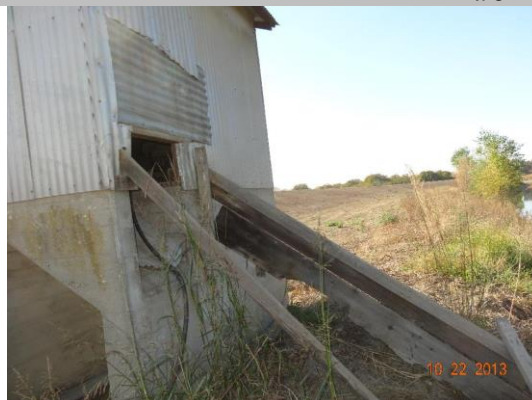
Photo 2 of 3 : UCIP_FA_2019_23964_42116.jpg

No pipe exists the pump house on waterward side.

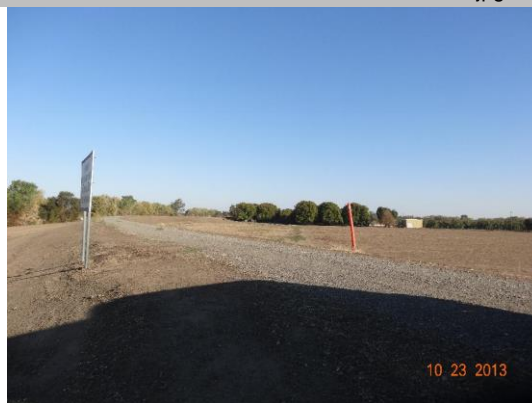
Photo 1 of 3 : UCIP_FA_2019_23965_42123.jpg

Item	DRAFT DWR UCIP Field Study		39.133847 °	39.133847 °								
			-121.937689 °	-121.937689 °								
DWR ID	21385											
Comment Code												
Inspector Comment												
DS_ID:21385 FS_ID:23965 EP_NO: 4383 Repair Type: Non-Urgent Crossing Status: Found UCIP Comments: Need to contact owner to determine if crossing is still active and to determine last inspection date. Will need copy of letter showing crossings passed inspection. This crossing is referenced in the USACE Periodic Inspection as item USACE_CESPK_MRD2_2012_p_0319. FIELD_STRUCT_DESC: 8.625-inch steel natural gas pipeline through the levee, 3.5 feet below the crown. Concrete cutoff wall around the pipe at the center of the levee. Rock revetment on the waterside (WS) slope. (Plans for construction, maintenance, and use of an 8.625-inch gas line authorized under Permit No. 4383, 1963 - Pacific Gas and Electric Company [PG&E]). [Additional Reference(s): DWR Levee Log, 2007]. FS Date: 10/23/2013

Markers visible on both levee shoulders.

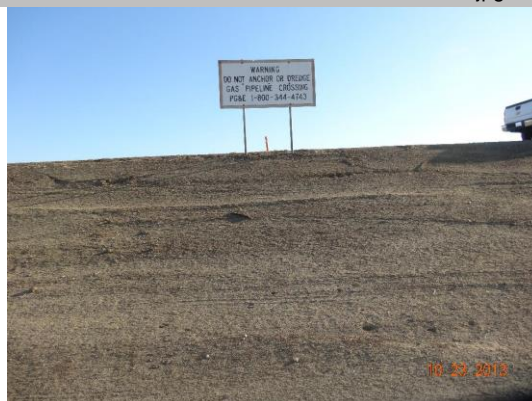
Photo 2 of 3 : UCIP_FA_2019_23965_42121.jpg

View of waterward slope.

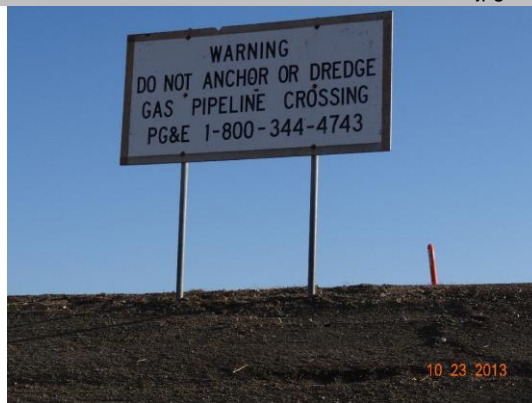
Photo 3 of 3 : UCIP_FA_2019_23965_42122.jpg

Sign visible on waterward side.

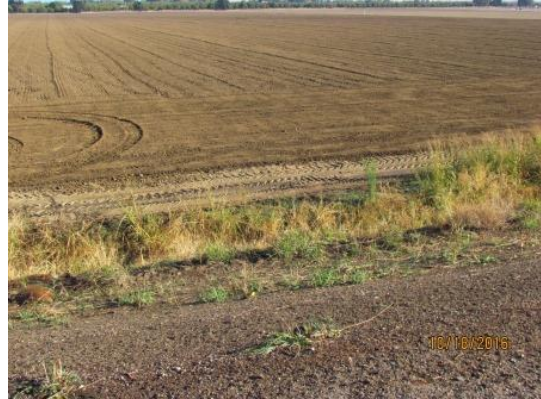
Photo 1 of 1 : FA_2019_RD0070_30_56_20190822_00006.jpg

LM Start	6.32	Rating **	M	Issue No.	56
LM End	7.09	Issue Type +	En	Location *	LS
Category	Earthen Levee			GPS Latitude/Longitude	
				Start	End
Item	Encroachments			39.133450 °	39.129024 °
				-121.937361 °	-121.924632 °
DWR ID	DWR_RD0070_02_f _ 2016_56				
Comment Code					
DT : Ditch					
Inspector Comment

View of a ditch at the landside toe.

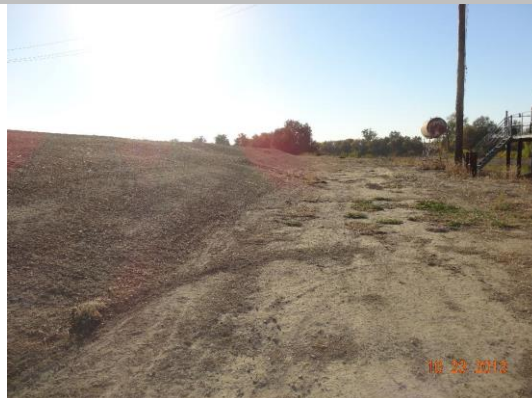
Photo 1 of 3 : UCIP_FA_2019_46424_42043.jpg

DS_ID:21386
FS_ID:46424
EP_NO: 9994
Repair Type: Non-Urgent
Crossing Status: Found
UCIP Comments: 07/28/2015 System was running during site visit. Damage to landward side has been repaired. No records available to determine cause of erosion--monitor. No other issues observed during site visit. 10/23/2013 Erosion visible on landward side behind concrete headwall. Plastic sheeting has been placed to protect slope. Need to determine cause for erosion, is pipe leaking? Pipe wall on landward side has deteriorated significantly that the wall is gone. Owner will need to coordinate with DWR inspector and CVFPB to address issue. Recommend notifying owner to stop using crossing until issue has been addressed. This crossing is referenced in the USACE Periodic Inspection as item USACE_CESPK_MRD2_2012_p_0324.
FIELD_STRUCT_DESC: 20-inch coated steel irrigation discharge pipe on the waterside (WS) and 24-inch coated steel irrigation discharge pipe on the landside (LS) through the levee, 12.5 feet below the crown. Pipe is concrete encased under the crown, between the shoulders. Slide gate in a metal well on the WS slope. Pump on a pile structure in the stream. Concrete discharge box at the LS toe. Service pole on the WS slope. (Plans for the installation of an irrigation pumping plant and appurtenant electrical power line across the levee authorized under Permit No. 1202, 19 - Hannah R. Jacobs. Retention of a 24-inch concrete encased steel pipe through the levee, 12.5 feet below the crown, a pump, a slide gate, and a concrete discharge box authorized under Automatic Board Order (ABO) issued as Permit No. 9994, 1974 - R. X. Ranch Company). [Additional Reference(s): DWR Levee Log, 2007. USACE Sacramento O&M Manual 134, June 1953, (Station 610+84)].

View of levee slope and berm on waterward side.

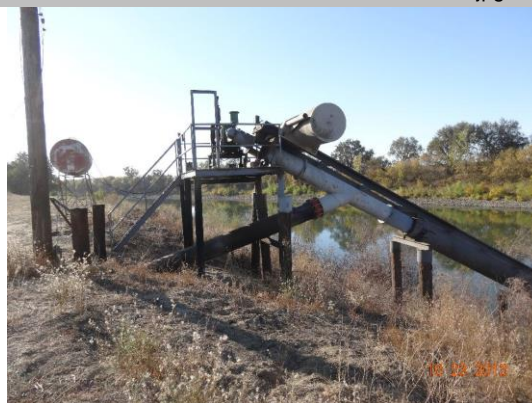
Photo 2 of 3 : UCIP_FA_2019_46424_42049.jpg

Pipe and pump set up on waterward side.

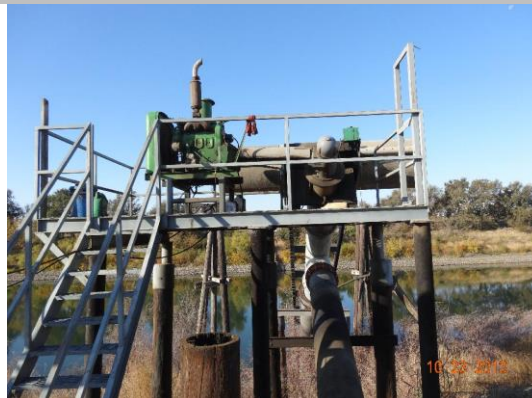
Photo 3 of 3 : UCIP_FA_2019_46424_42047.jpg

Stairs and platform located on waterward side.

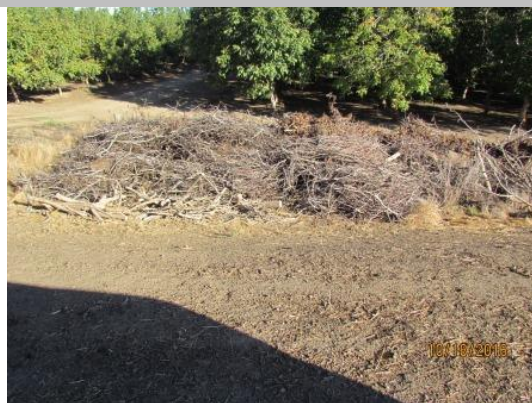
Photo 1 of 1 : FA_2019_RD0070_30_58_20190822_00008.jpg

LM Start	7.64	Rating **	M	Issue No.	58
LM End	7.64	Issue Type +	En	Location *	LS
Category	Earthen Levee			GPS Latitude/Longitude	
				Start	End
Item	Encroachments			39.124479 °	39.124479 °
				-121.917081 °	-121.917081 °
DWR ID	DWR_RD0070_02_f_2016_58				
Comment Code					
PR : Prunings					
Inspector Comment					
Remove prunings from the landside toe.

View of the prunings along the landside toe.

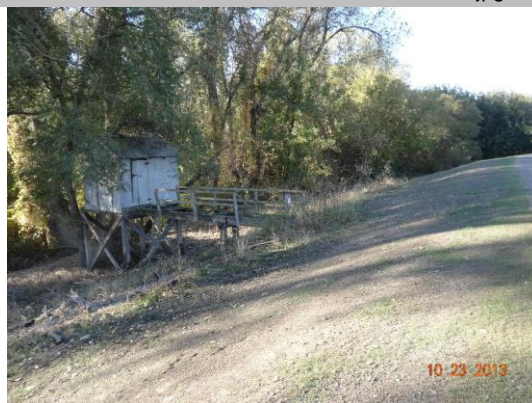
Photo 1 of 3 : UCIP_FA_2019_23966_42128.jpg

Comment Code					
Inspector Comment					
DS_ID:21387 FS_ID:23966 EP_NO: 9966 Repair Type: Non-Urgent Crossing Status: Indicator Found UCIP Comments: Pipe daylight at waterward side blocked. Unable to determine if connection is present--need to contact owner to determine if owner plans to use. If crossing is no longer in use owner will need to coordinate with DWR inspector and CVFPB to remove according to Title 23 requirements. Unable to determine if crossing is in use. This crossing is referenced in the USACE Periodic Inspection as item USACE_CESPK_MRD2_2012_p_0371. FIELD_STRUCT_DESC: 10-inch coated steel irrigation discharge pipe and 1.5-inch electrical conduit of an unknown material through the levee, 12 feet and 8 feet below the crown, respectively. Pipe is concrete encased under the crown, between the shoulders. Concrete cutoff wall under each shoulder. Pump and gate valve on a pile structure in the stream. Walkway to the pump. Concrete standpipe on the landside (LS). (retain 10-inch concrete-encased steel pipe, pump and gate valve, concrete standpipe, and two concrete headwalls authorized under Automatic Board Order (ABO) issued as Permit No. 9966, 1976 - Ray and Janice Anderson). [Additional Reference(s): DWR Levee Log, 2007. USACE Sacramento O&M Manual 134, June 1953, (Station 689+50)]. FS Date: 10/23/2013

Pump house located on waterward side.

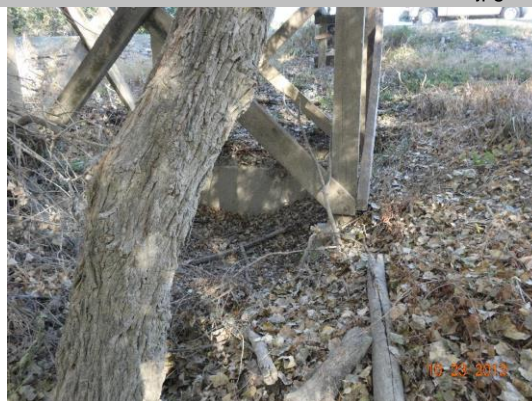
Photo 2 of 3 : UCIP_FA_2019_23966_42126.jpg

Comment Code						
Inspector Comment						
DS_ID:21387 FS_ID:23966 EP_NO: 9966 Repair Type: Non-Urgent Crossing Status: Indicator Found UCIP Comments: Pipe daylight at waterward side blocked. Unable to determine if connection is present--need to contact owner to determine if owner plans to use. If crossing is no longer in use owner will need to coordinate with DWR inspector and CVFPB to remove according to Title 23 requirements. Unable to determine if crossing is in use. This crossing is referenced in the USACE Periodic Inspection as item USACE_CESPK_MRD2_2012_p_0371. FIELD_STRUCT_DESC: 10-inch coated steel irrigation discharge pipe and 1.5-inch electrical conduit of an unknown material through the levee, 12 feet and 8 feet below the crown, respectively. Pipe is concrete encased under the crown, between the shoulders. Concrete cutoff wall under each shoulder. Pump and gate valve on a pile structure in the stream. Walkway to the pump. Concrete standpipe on the landside (LS). (retain 10-inch concrete-encased steel pipe, pump and gate valve, concrete standpipe, and two concrete headwalls authorized under Automatic Board Order (ABO) issued as Permit No. 9966, 1976 - Ray and Janice Anderson). [Additional Reference(s): DWR Levee Log, 2007. USACE Sacramento O&M Manual 134, June 1953, (Station 689+50)]. FS Date: 10/23/2013

Concrete headwall located on waterward side.

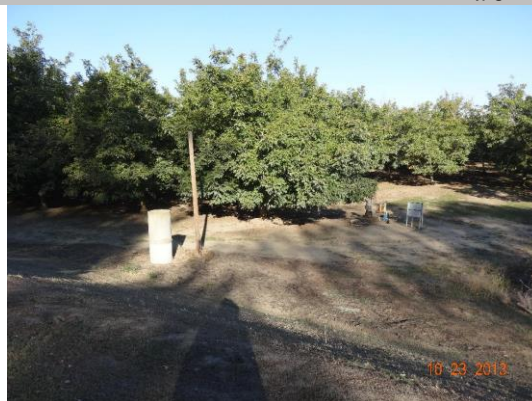
Photo 3 of 3 : UCIP_FA_2019_23966_42127.jpg

Stand pipe located on landward side.

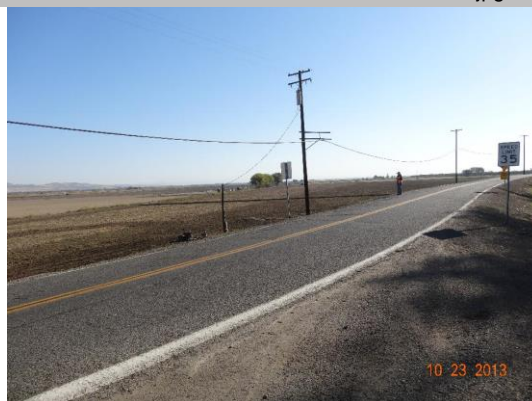
Photo 1 of 3 : UCIP_FA_2019_24191_42677.jpg

Comment Code					
Inspector Comment					
DS_ID:21389 FS_ID:24191 EP_NO: 1264 Repair Type: Non-Urgent Crossing Status: Indicator Found UCIP Comments: Need to coordinate with owner to determine status of crossing. If crossing is no longer in use owner will need to contact the CVFPB to comply with Title 23. This crossing is referenced in the USACE Periodic Inspection as item USACE_CESPK_MRD2_2012_p_0124. FIELD_STRUCT_DESC: *ABANDONED* 10-inch (not 14-inch as specified in the permit) irrigation discharge pipe of an unknown material through the levee, 5 feet below the crown. Pump on the waterside (WS). Double concrete discharge box at the landside (LS) toe. (Plans for installing an irrigation pumping plant and a 14-inch steel discharge pipe through the levee authorized under Permit No. 1264, 1948 - Robert Chesney). [Additional Reference(s): DWR Levee Log, 2007]. FS Date: 10/23/2013

View of levee crown at crossing.

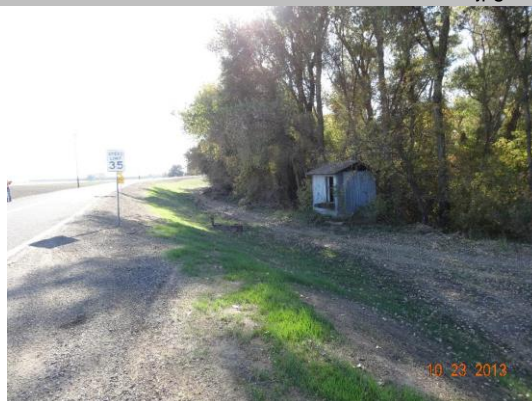
Photo 2 of 3 : UCIP_FA_2019_24191_42678.jpg

View of waterward side--only pump house of nearby crossing located downstream from crossing.

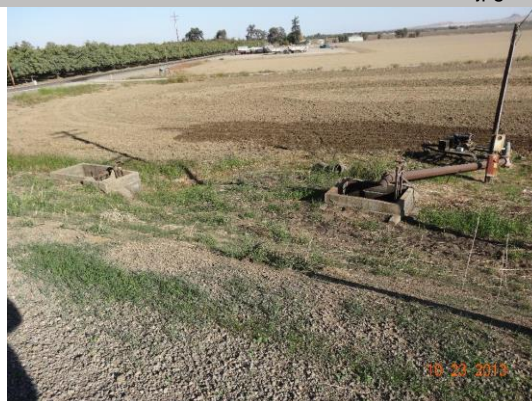
Photo 3 of 3 : UCIP_FA_2019_24191_42676.jpg

Comment Code						
Inspector Comment						
DS_ID:21389 FS_ID:24191 EP_NO: 1264 Repair Type: Non-Urgent Crossing Status: Indicator Found UCIP Comments: Need to coordinate with owner to determine status of crossing. If crossing is no longer in use owner will need to contact the CVFPB to comply with Title 23. This crossing is referenced in the USACE Periodic Inspection as item USACE_CESPK_MRD2_2012_p_0124. FIELD_STRUCT_DESC: *ABANDONED* 10-inch (not 14-inch as specified in the permit) irrigation discharge pipe of an unknown material through the levee, 5 feet below the crown. Pump on the waterside (WS). Double concrete discharge box at the landside (LS) toe. (Plans for installing an irrigation pumping plant and a 14-inch steel discharge pipe through the levee authorized under Permit No. 1264, 1948 - Robert Chesney). [Additional Reference(s): DWR Levee Log, 2007]. FS Date: 10/23/2013

View of landward side--two crossing nearby.

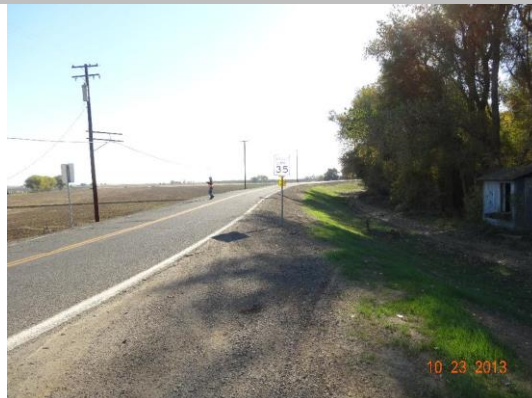
Photo 1 of 3 : UCIP_FA_2019_24190_42667.jpg

DS_ID:21388
FS_ID:24190
EP_NO: 10008
Repair Type: Non-Urgent
Crossing Status: Found
UCIP Comments: Concrete distribution box is damage on waterward side. Need to contact owner to determine status of crossing. If crossing is no longer in use owner will need to coordinate with DWR inspector and CVFPB to remove according to Title 23 requirements. This crossing is referenced in the USACE Periodic Inspection as item USACE_CESPK_MRD2_2012_p_0380.
FIELD_STRUCT_DESC: *ABANDONED* 18-inch steel irrigation discharge pipe through the levee, 15 feet below the crown. Pump in a pump house on the waterside (WS). Slide gate on the WS. Concrete distribution box on the landside (LS). During field verification, additional appurtenances were observed. An additional pipe on the LS drains into the concrete distribution box. The concrete distribution box connects to a second set of distribution boxes through a 24-inch reinforced concrete pipe approximately 36 feet upstream of the crossing. Those boxes have a 10-inch pipe which appears to go through the levee. (Retention of an 18-inch corrugated metal pipe (CMP) through the levee, 15 feet below the crown, a pump, a slide gate, and a concrete distribution box authorized under Automatic Board Order (ABO) issued as Permit No. 10008, 1974 - Frances C. Yates). [Additional Reference(s): DWR Levee Log, 2007. USACE Sacramento O&M Manual 134, June 1953, (Station 694+85)].

View of levee crown at crossing.
